**CONSTRUCTION NOTICE**

**Hanna-Highland 345 kV Transmission Line Loop to Trumbull  
Substation Project**

**Case No. 24-0440 -EL-BNR**

**May 20, 2024**

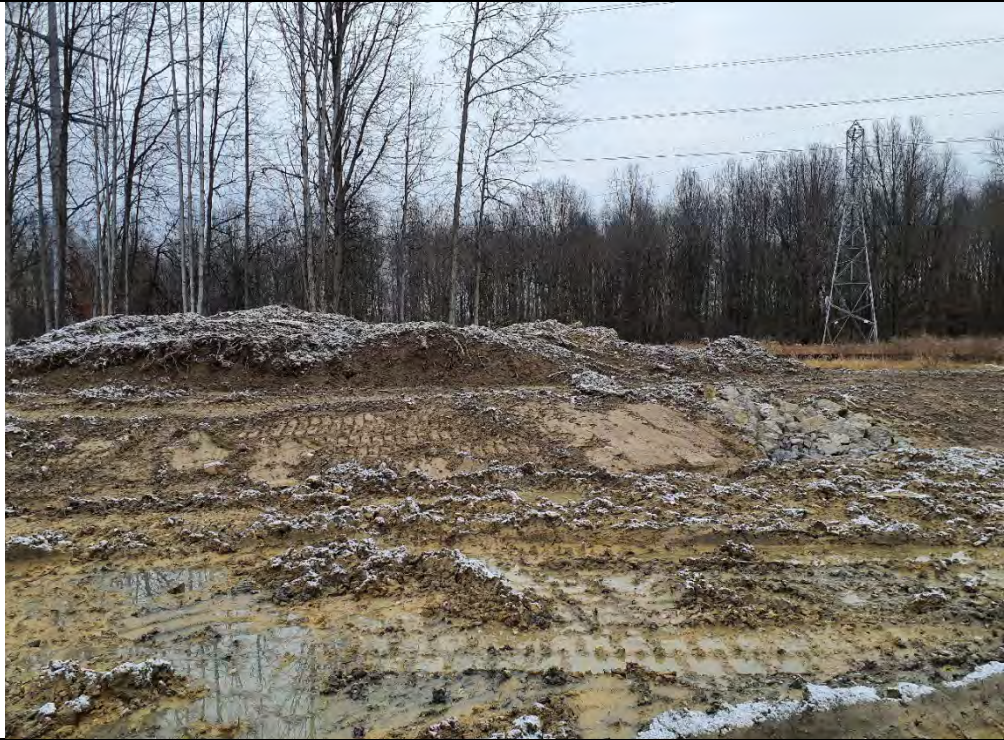
**Photo No. 8.**

Representative photo of the center of the Study Area, facing east, showing current tree clearing west of the existing utility corridor.

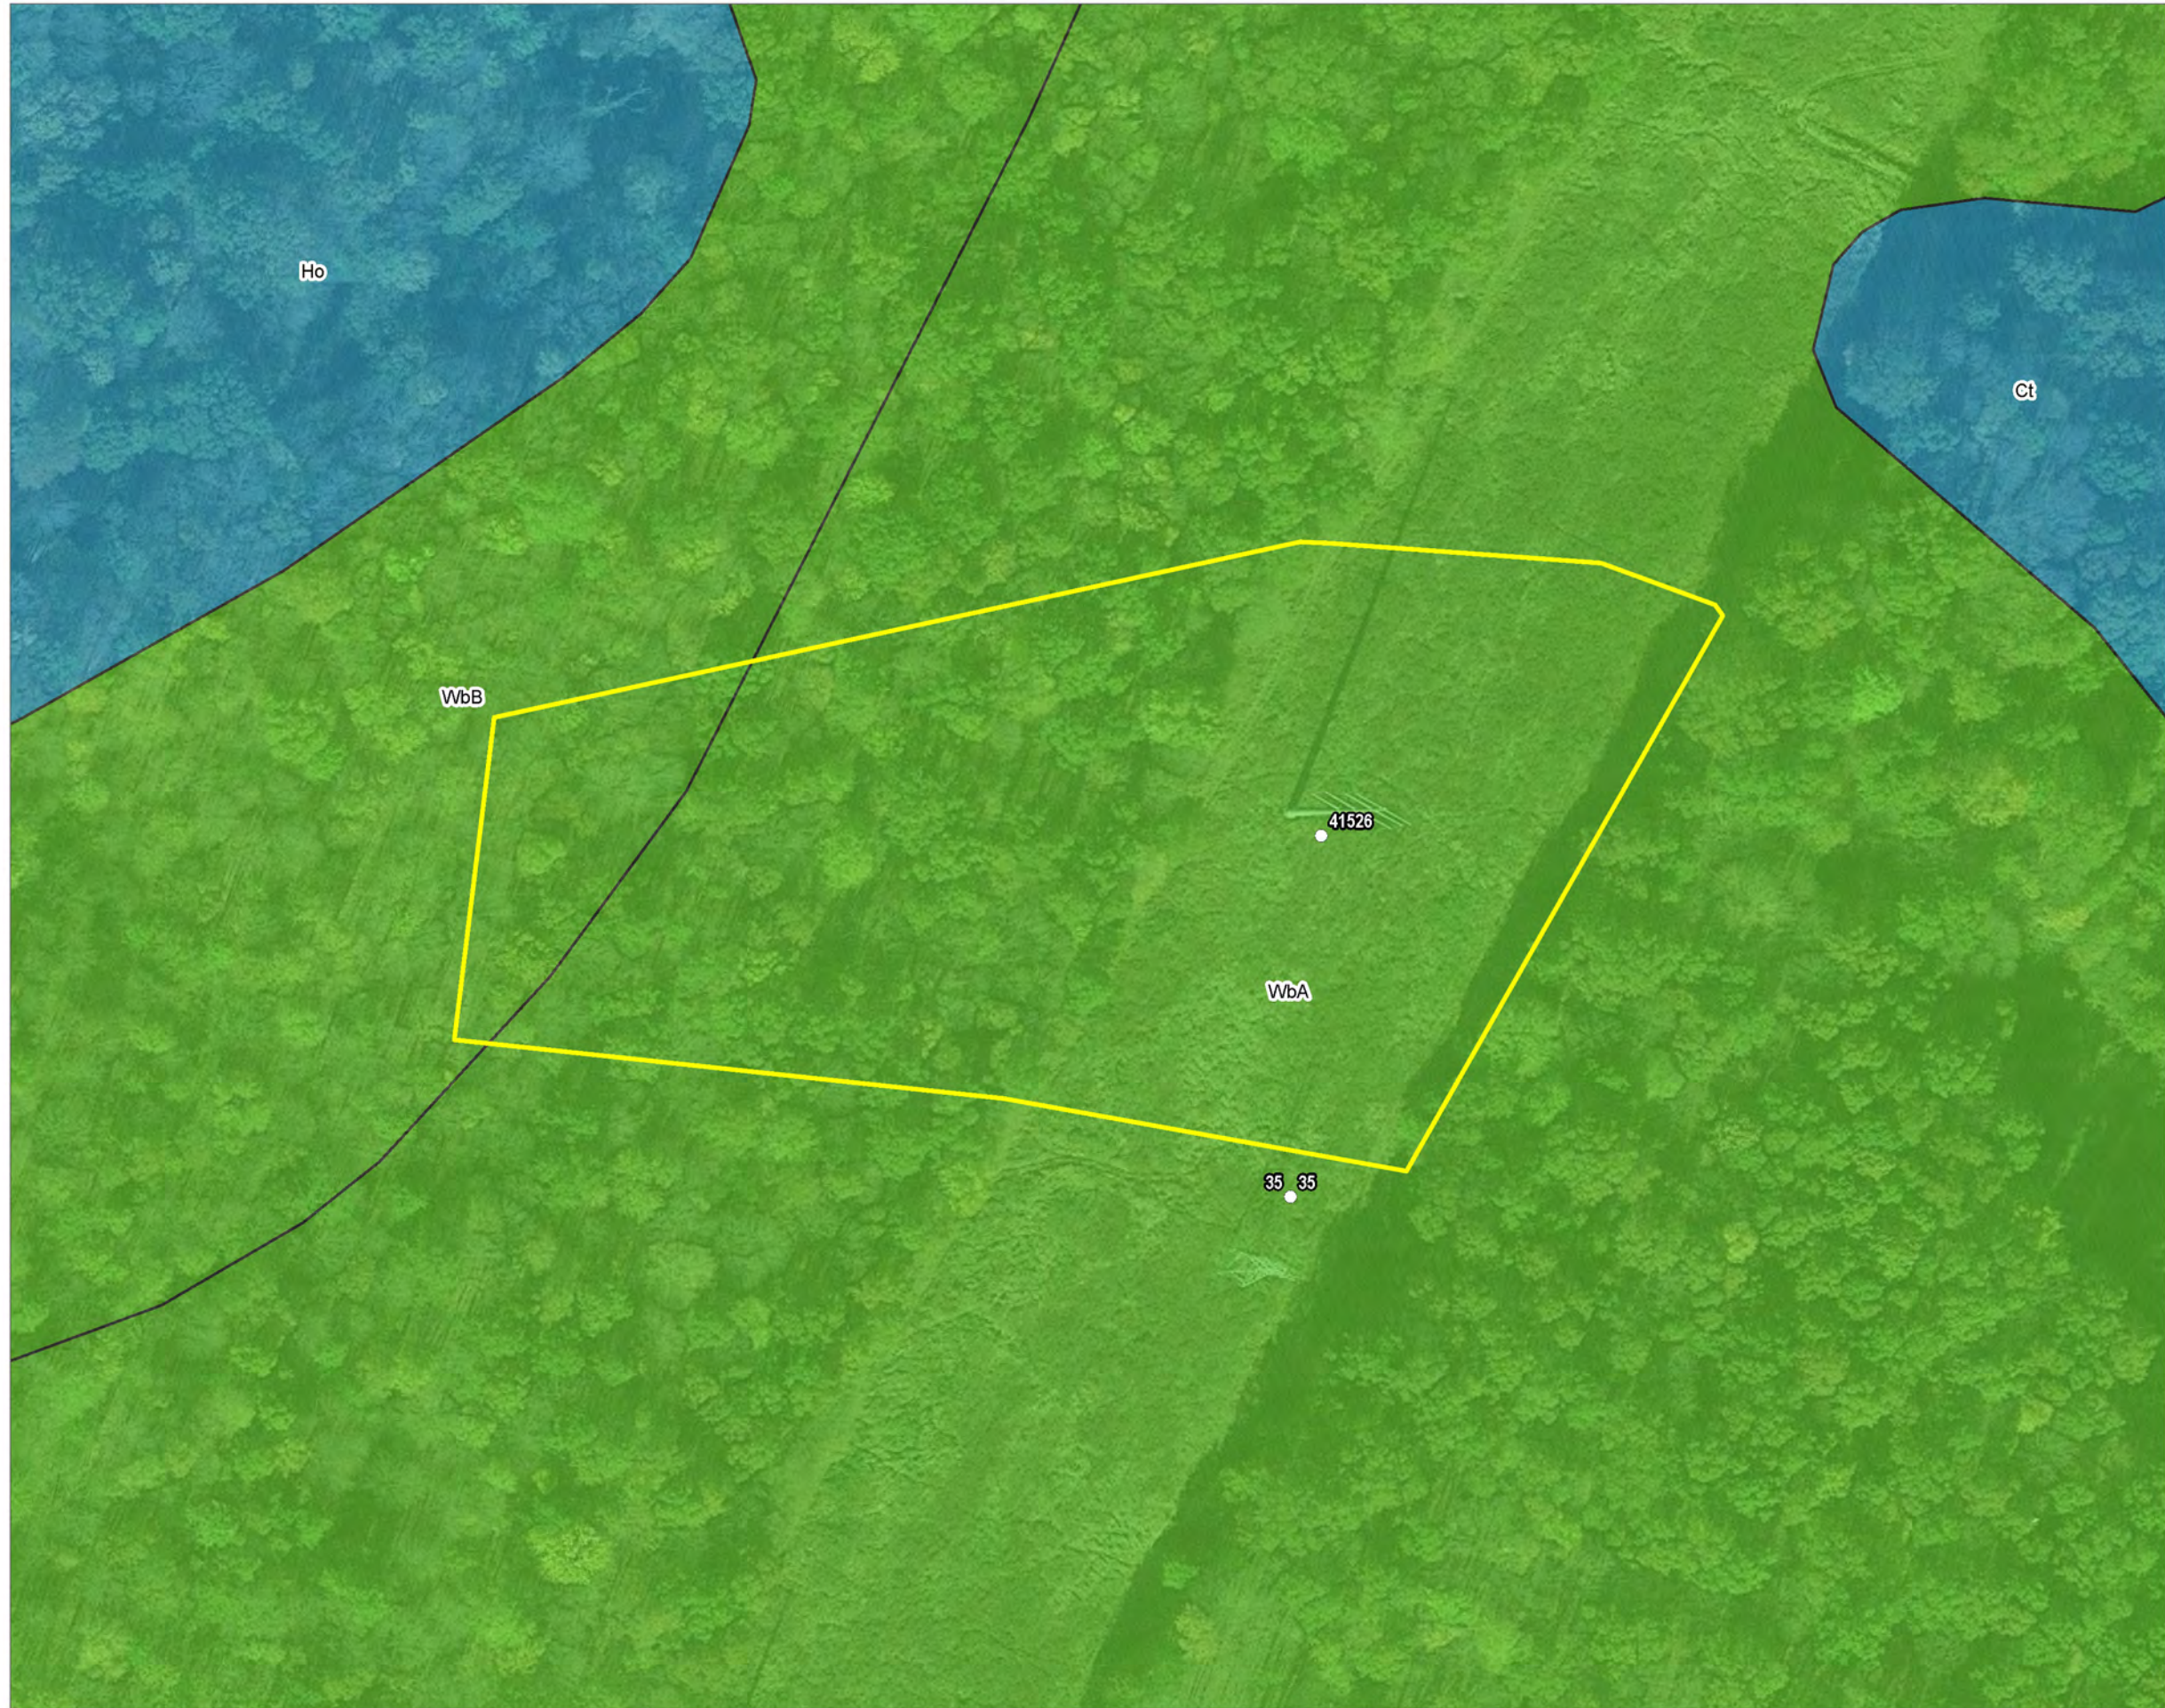
- PROJECT STUDY AREA
- EXISTING STRUCTURE
- HYDRIC SOIL
- NON-HYDRIC W/ HYDRIC INCLUSIONS SOIL
- NON-HYDRIC SOIL

BASE MAP: GOOGLE MAPS  
 DATA SOURCES: SOILS DATA ACQUIRED FROM USDA/NRCS SSURGO DATABASE

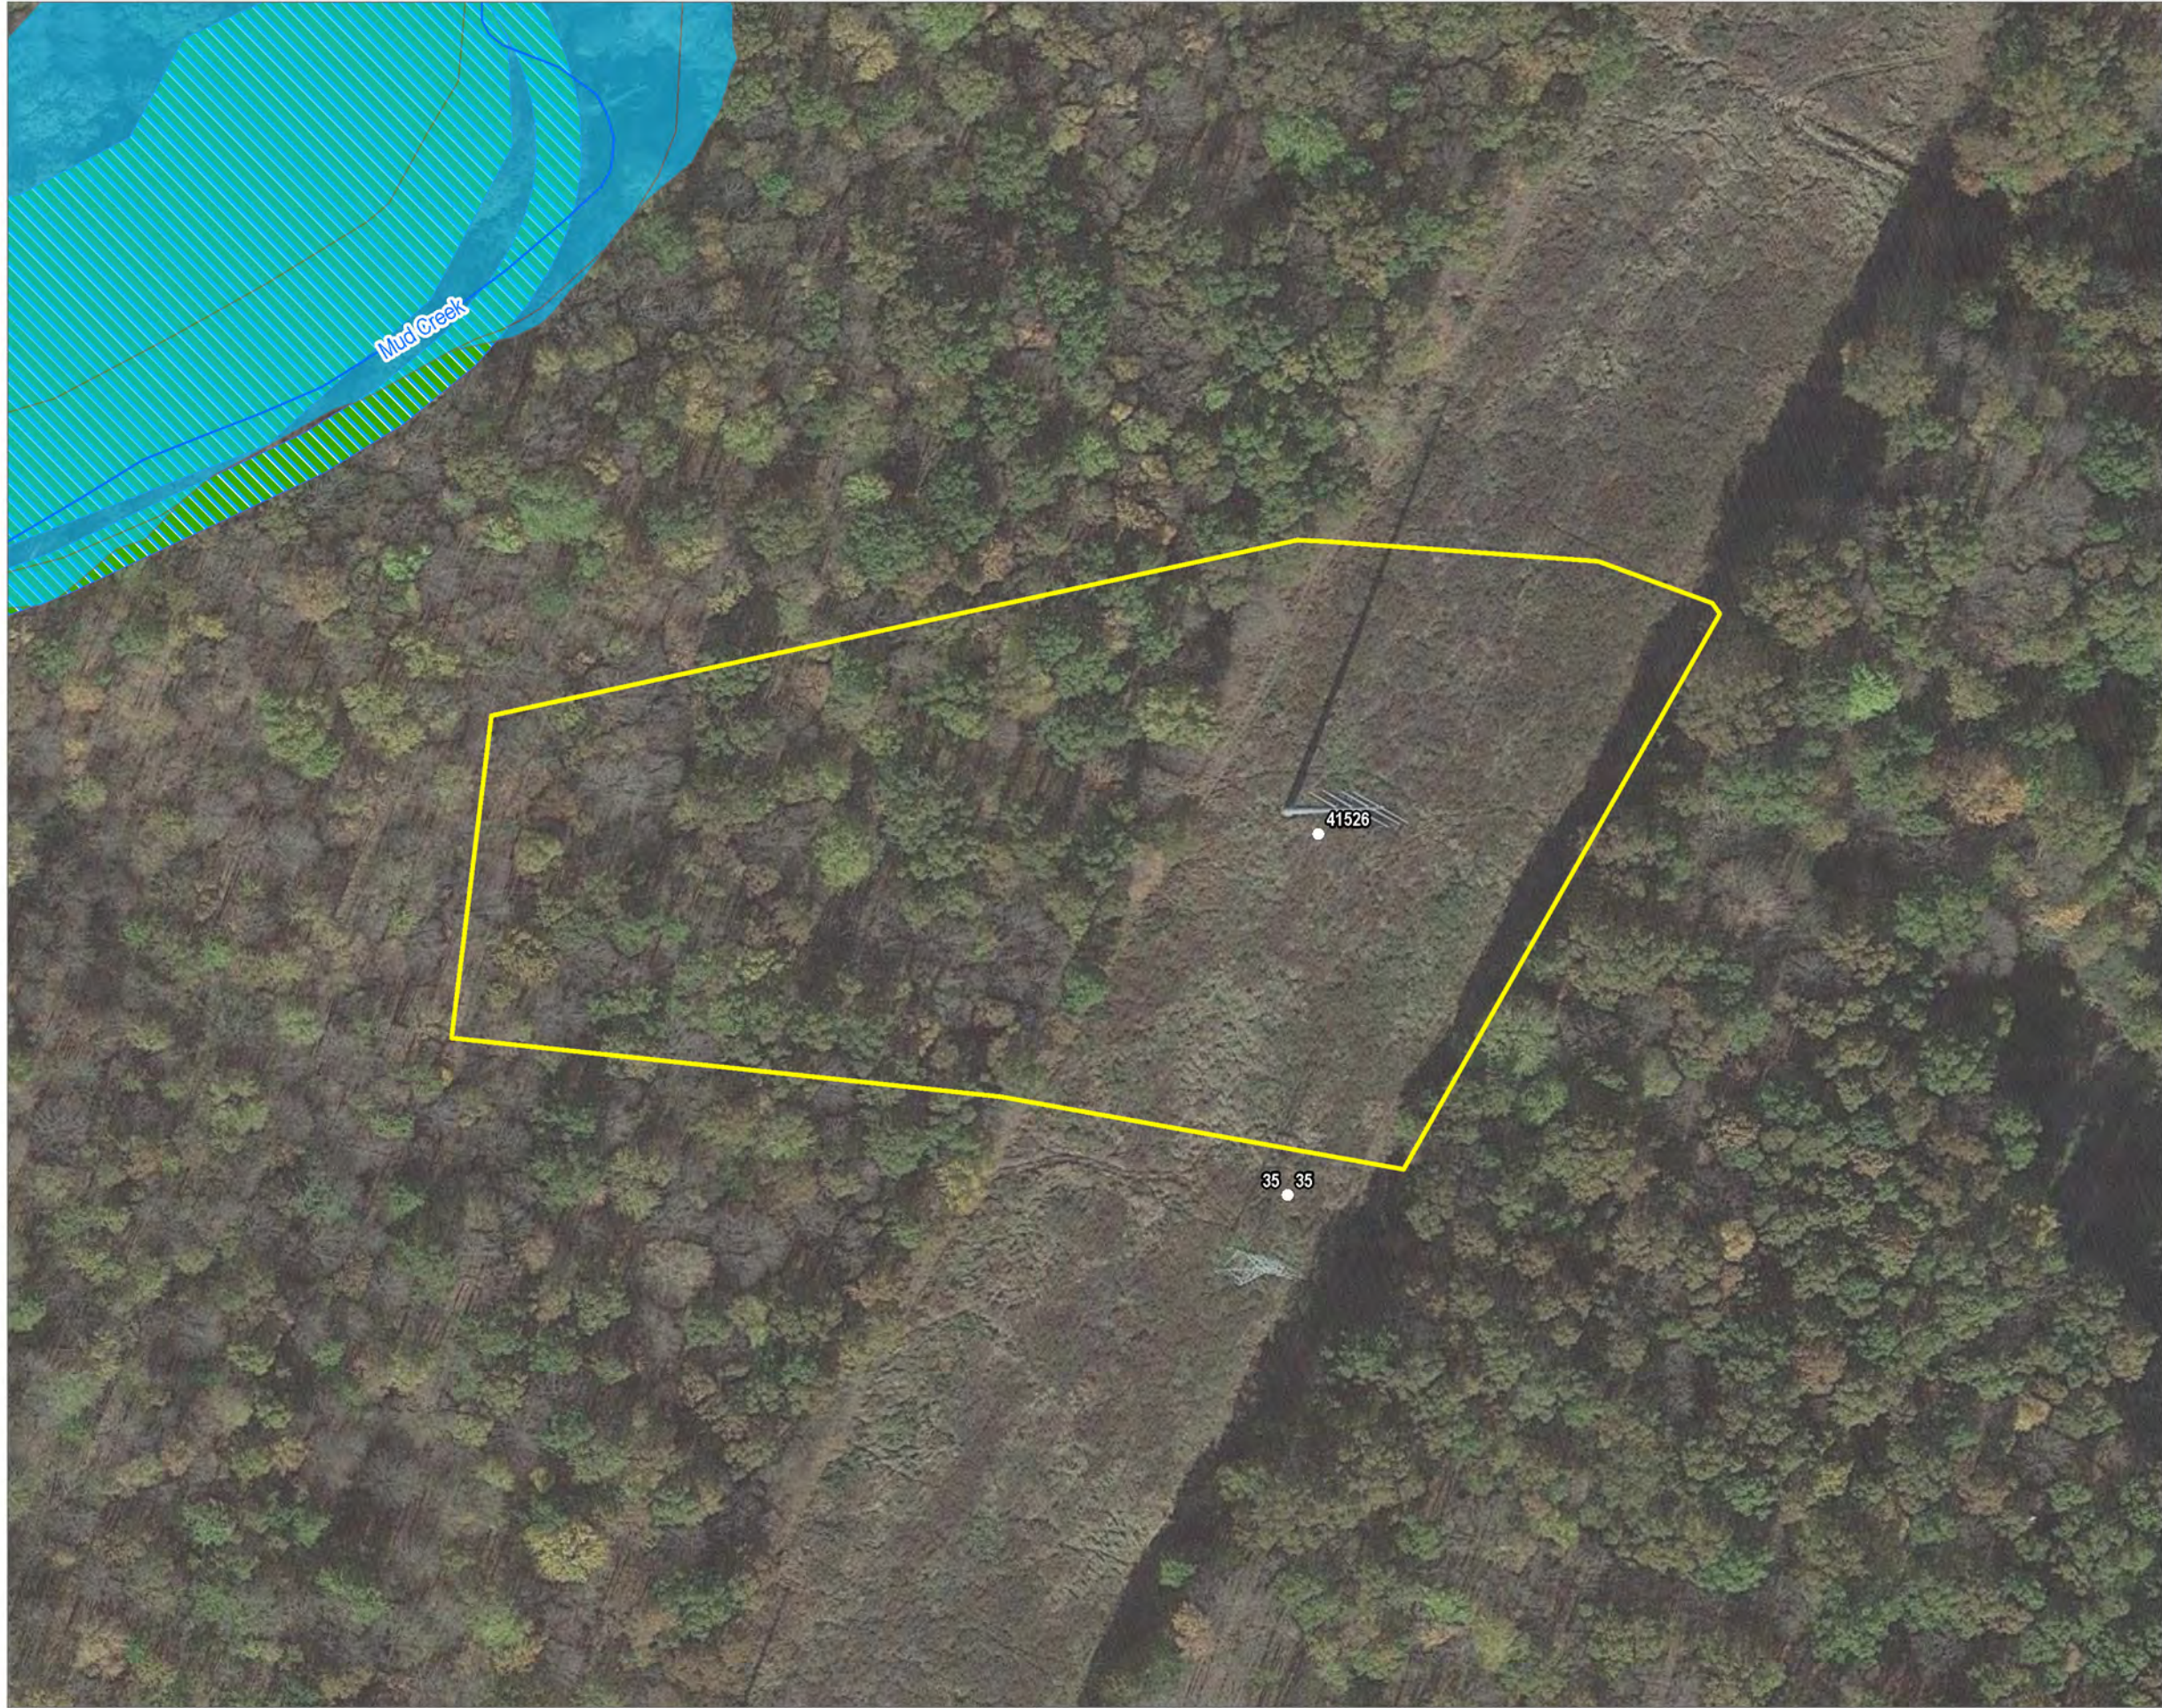
- PROJECT STUDY AREA
- EXISTING STRUCTURE
- NATIONAL HYDROGRAPHY DATASET (NHD) STREAM
- NATIONAL WETLANDS INVENTORY (NWI) FEATURE
- 100-YEAR FLOOD ZONE

BASE MAP: GOOGLE MAPS.  
 DATA SOURCES: WETLAND DATA ACQUIRED FROM U.S. FISH & WILDLIFE SERVICE, NATIONAL WETLANDS INVENTORY (NWI). STREAM DATA ACQUIRED FROM USGS, NATIONAL HYDROGRAPHY DATASET (NHD). FLOOD DATA ACQUIRED FROM FEMA, NATIONAL FLOOD HAZARD LAYER (NFHL).

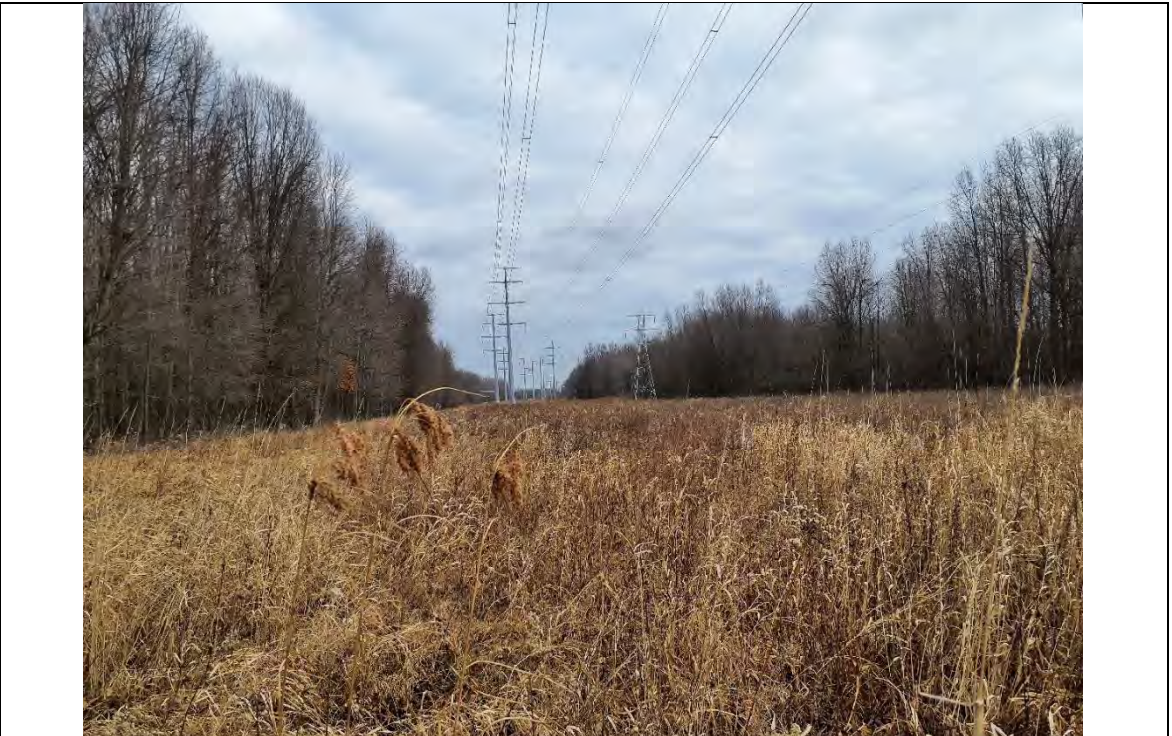
**Description:**  
Wetland W-EVN-1 (PEM), view looking north.

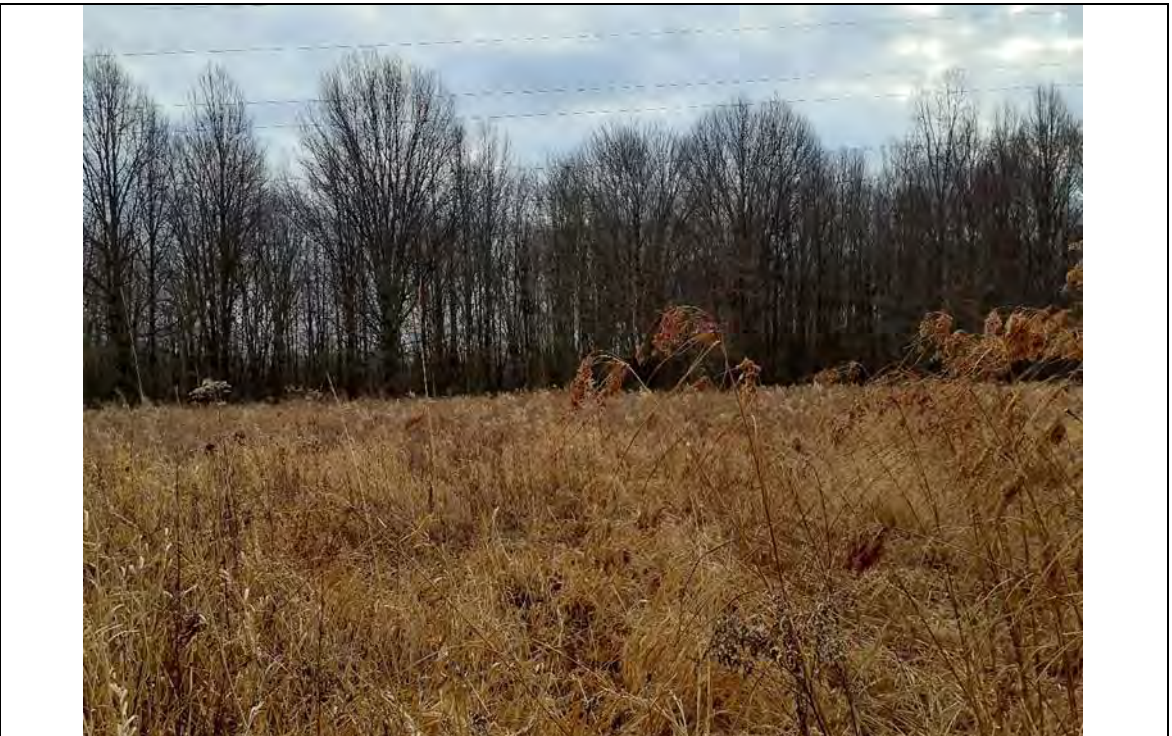
**Photo No. 2.**

**Description:**  
Wetland W-EVN-1 (PEM), view looking east.

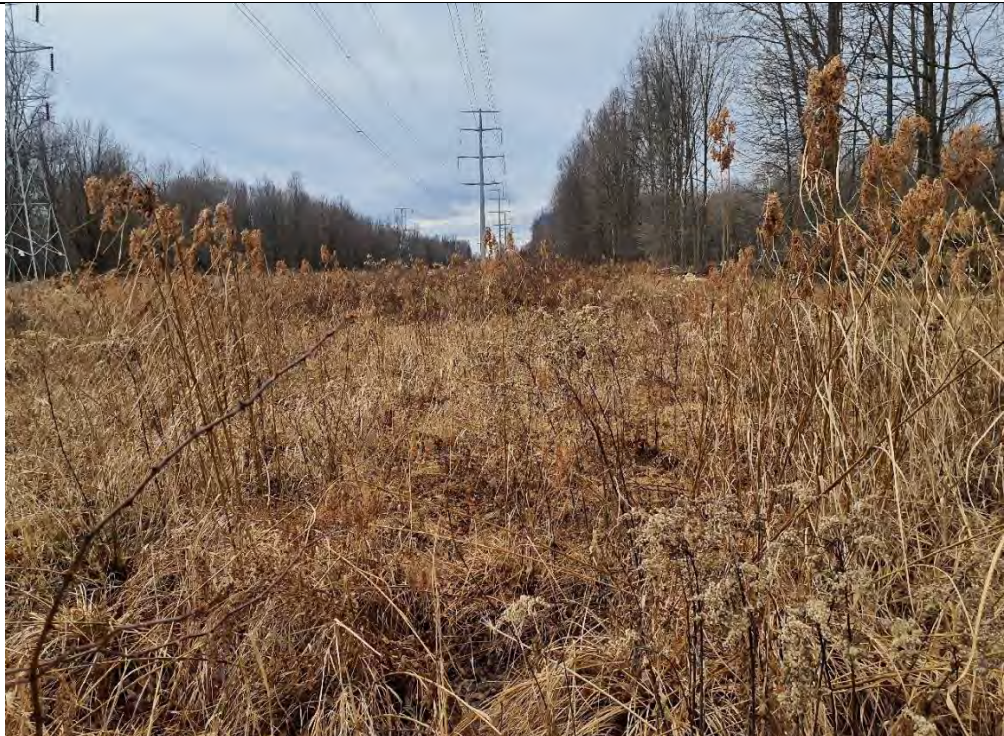
**Photo No. 3.**

**Description:**  
Wetland W-EVN-1 (PEM), view looking south.

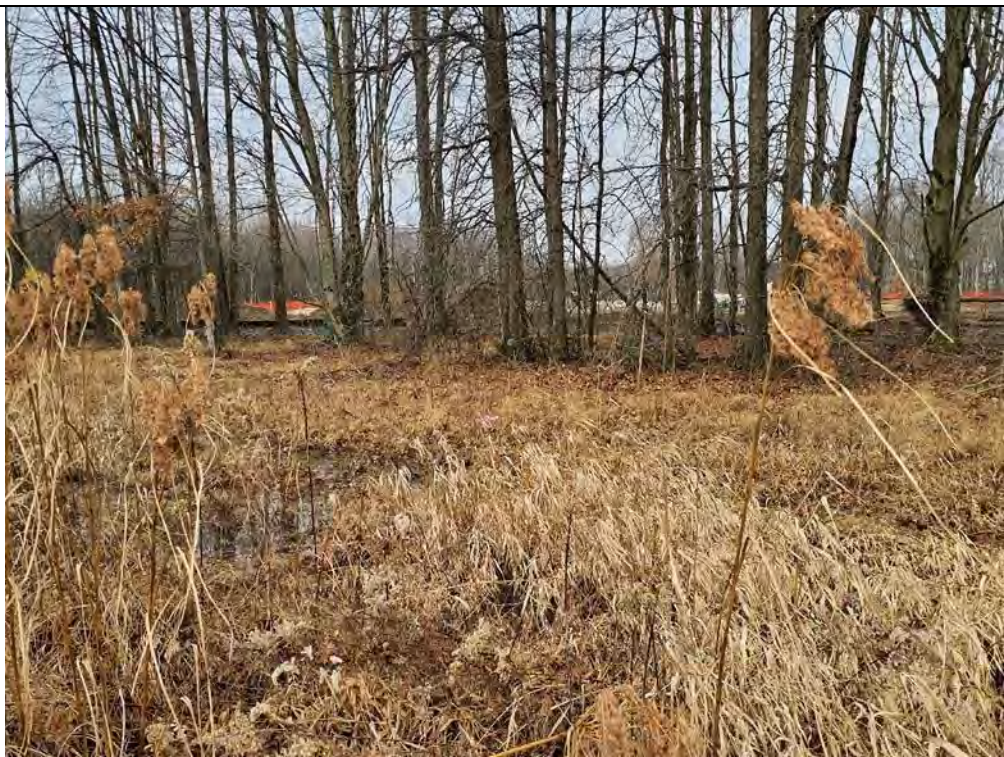
**Photo No. 4.**

**Description:**  
Wetland W-EVN-1 (PEM), view looking west.
