**LEVIS PARK-MIDWAY 138 KV
TRANSMISSION LINE SWITCH REPLACEMENT
PROJECT
OPSB CASE NO.: 24-0905-EL-BNR**

December 9, 2024

**CONSTRUCTION NOTICE
LEVIS PARK-MIDWAY 138 kV TRANSMISSION LINE
SWITCH REPLACEMENT PROJECT**

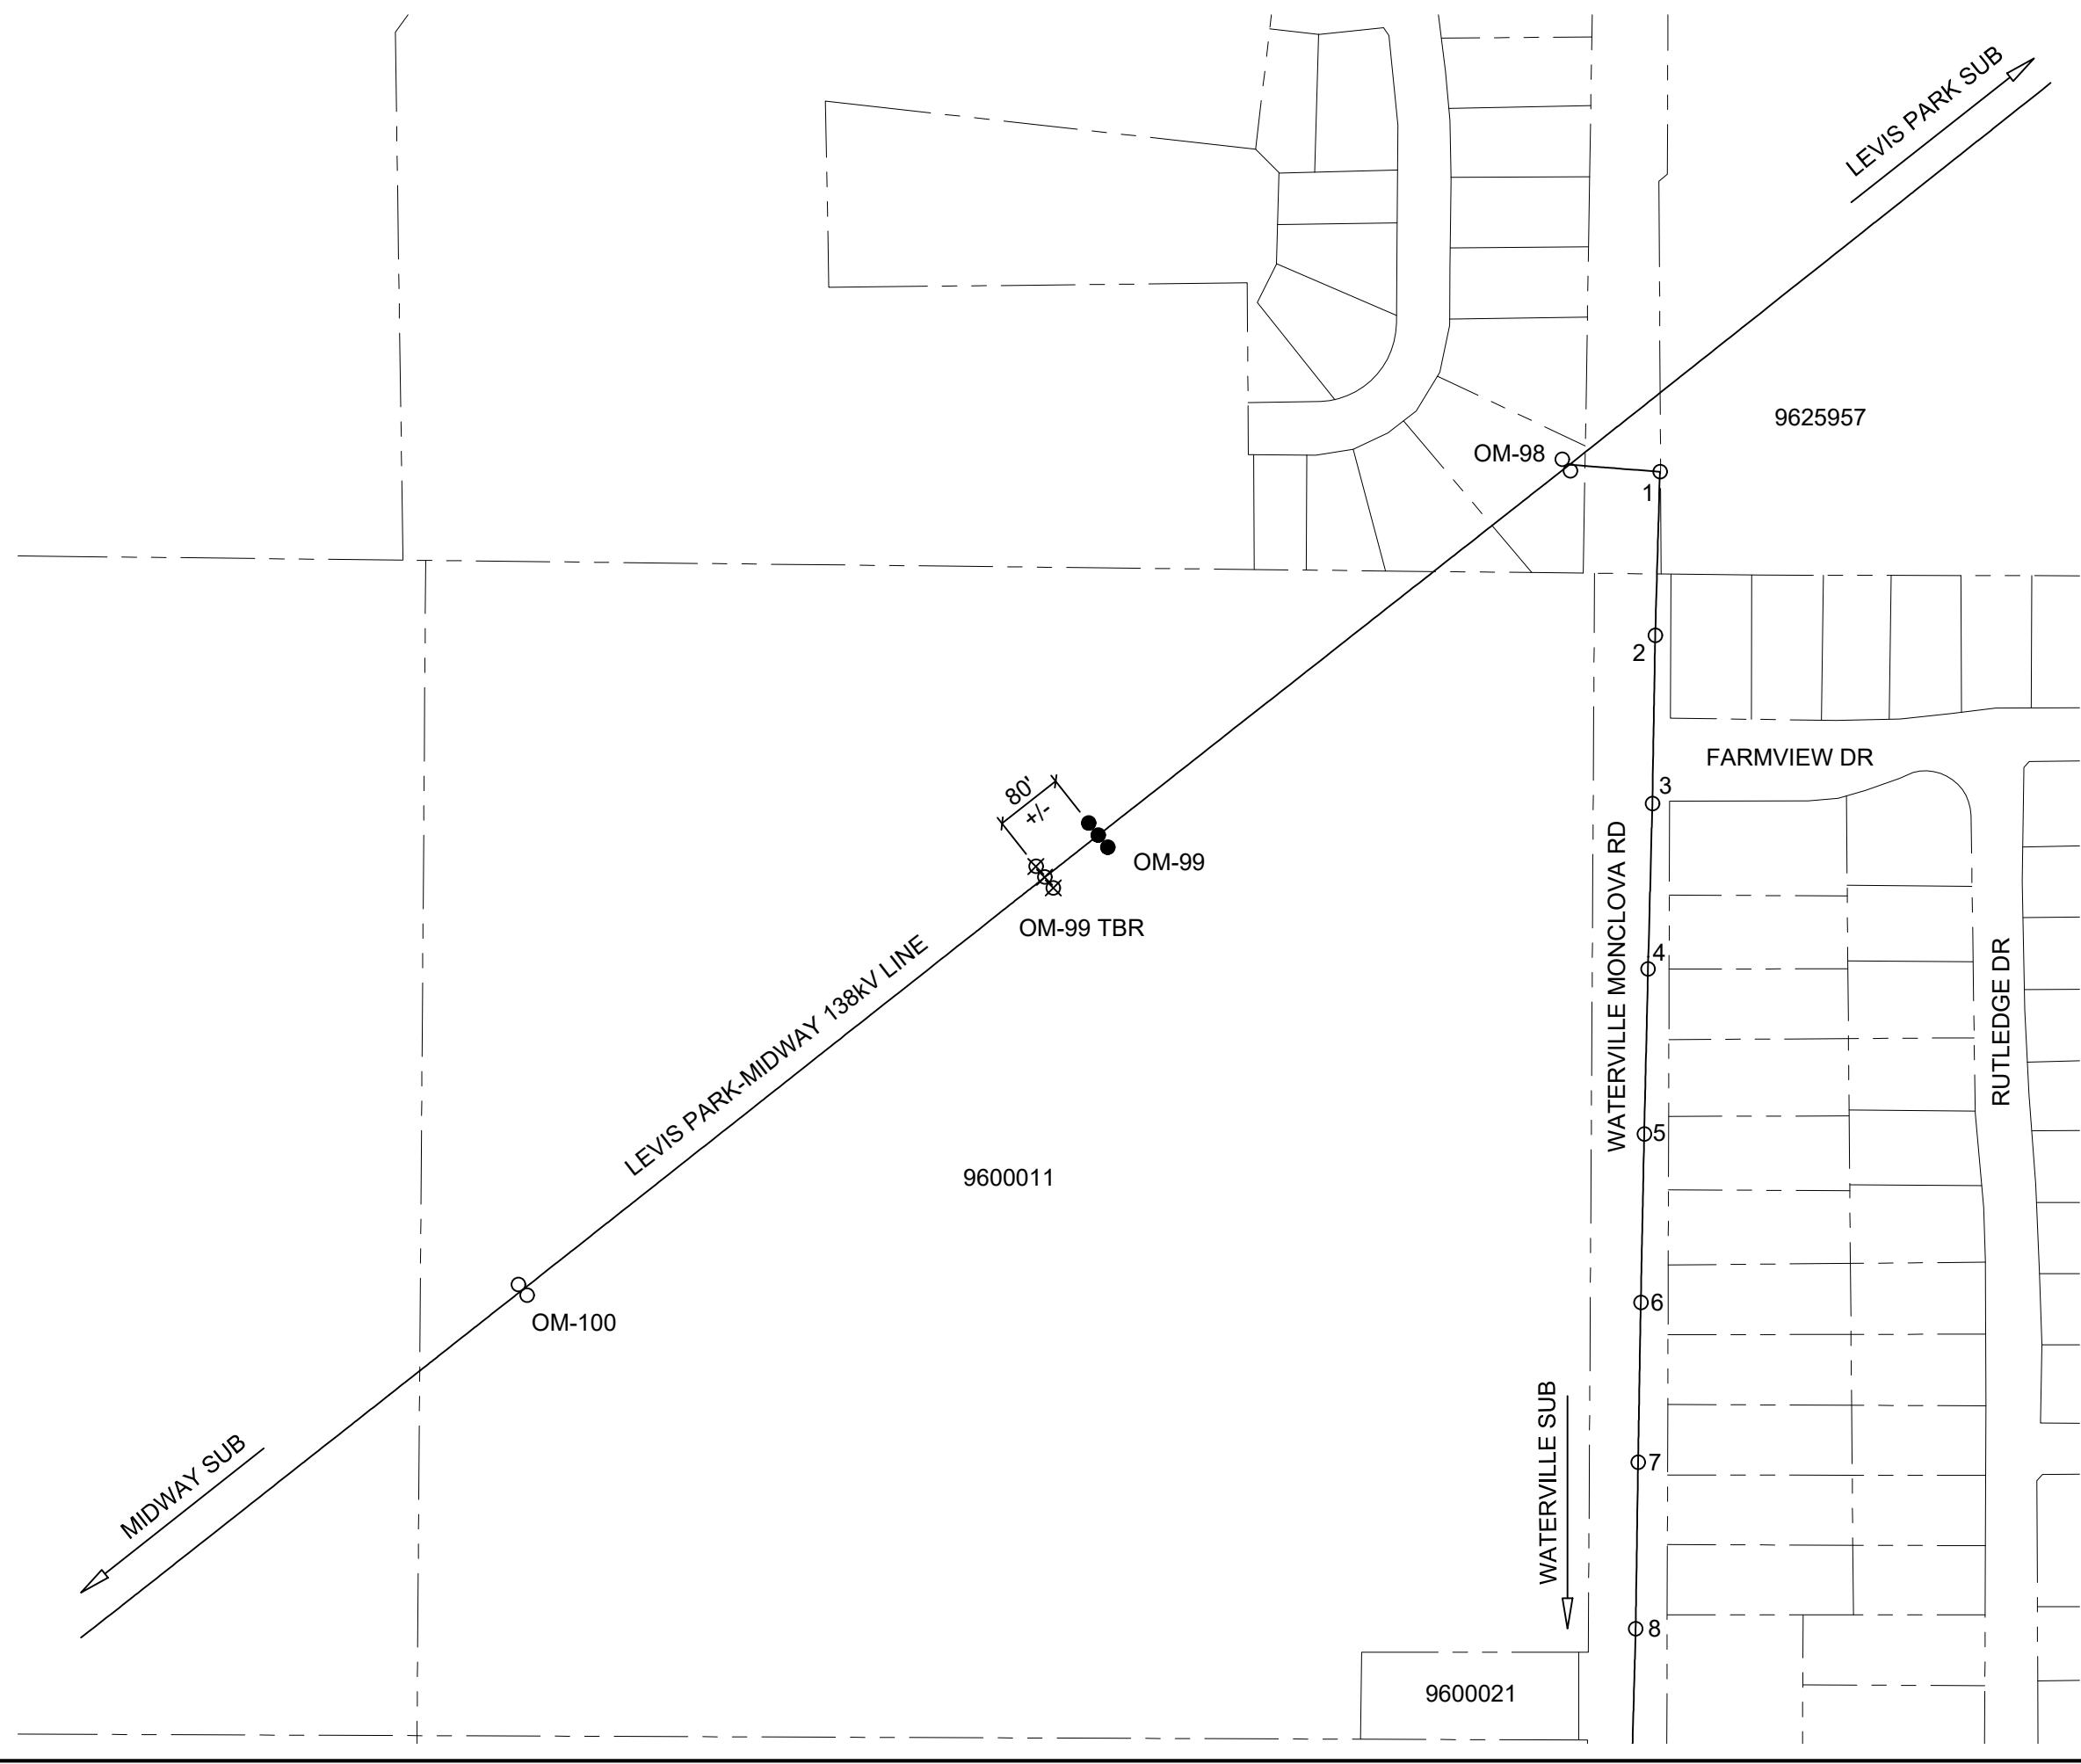
EXHIBIT 3

| LEGEND | |
|---|--|
| ● | --- REPLACED STEEL STRUCTURE W/ FOUNDATION |

**LEVIS PARK-MIDWAY 138KV LINE
SWITCH STRUCTURE
REPLACEMENT PROJECT**

The general location of the proposed Project is shown in Exhibits 1 and 2. Exhibit 1 is a partial copy of a United States Geologic Survey (“USGS”) Topographic Map, Lucas County, Ohio Quad Map. Exhibit 2 provides a partial copy of ESRI aerial imagery. The general layout is shown in Exhibit 3. The Project is in the City of Waterville, Lucas County, Ohio.

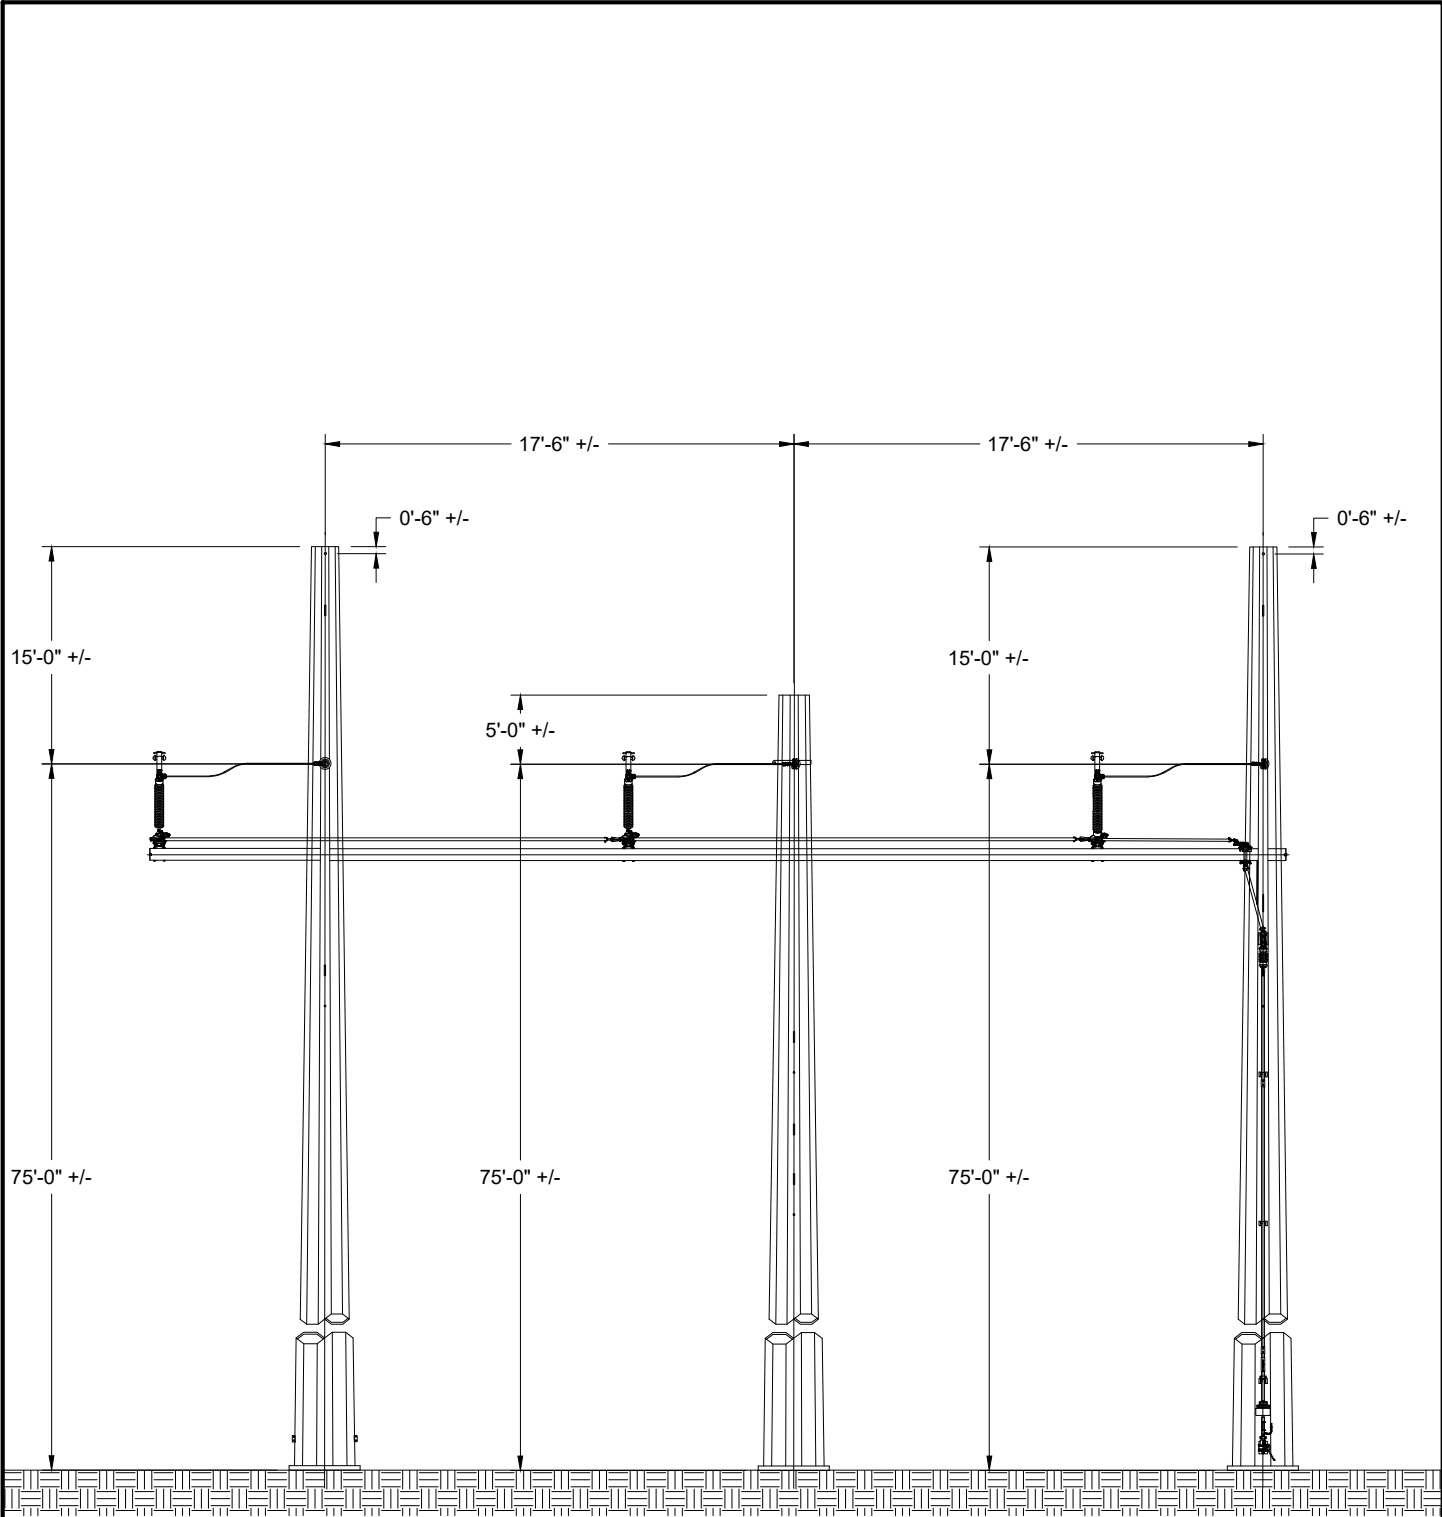
LEVIS PARK-MIDWAY 138kV LINE
 SWITCH STRUCTURE
 REPLACEMENT PROJECT

138KV STEEL POLE STRUCTURE WITH CONCRETE FOUNDATIONS
 2000A 750KV BIL UNITIZED SWITCH WITH WHIP INTERRUPTION

In this Project, American Transmission Systems, Incorporated (“ATSI”), a FirstEnergy company, proposes to replace an existing switch on the existing Levis Park-Midway 138 kV Transmission Line, with a new single-circuit steel three-pole switch structure on concrete foundations. The existing switch structure is a three-pole wood structure with guy wires and anchors that will be removed as part of the Project. The new structure will be located on the same centerline, approximately 80’ northeast from the existing structure OM-99. The conductor and shield wire will be transferred to the new structure.

The proposed solution is to replace both the structure and the switch, using an improved unitized design¹ meeting present engineering standards, while adding a motor capable of remote operation for enhanced system flexibility and personal safety.

¹ a "unitized" design is one in which all three phases of the operating mechanism are factory mounted to a single ridged rail and lifted to the structure as a unit. This is an improvement over the "phase-over-phase" design in which each phase is individually built onto a platform in the field from a box of parts. Factory assembly and testing removes field errors and mitigates deflection-caused binding because the switch on the frame moves as a single unit.
